# Improving the Past with the Economic Realities of Today

*Jordan Soll B.Sc. (Hon.), D.D.S., Dip ABAD, Trevor Laingchild RDT*

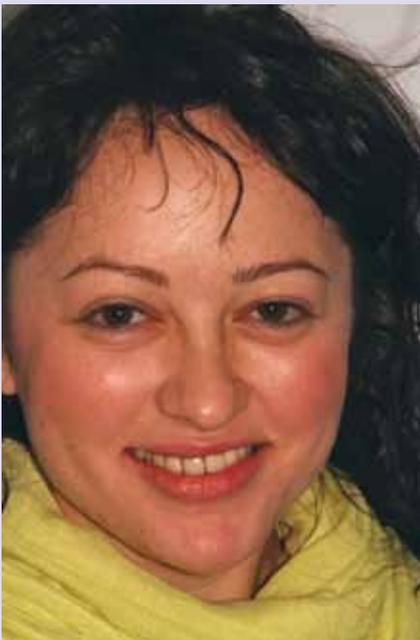
FIGURE 1

an attractive smile marred by four unattractive veneers (Figs. 1,2). These restorations were approximately ten years old and were characterized by stained margins, opaque in appearance and bulbous in nature with no suggestion of colour gradation. Teeth #'s 12 and 11 were previously endodontically-treated. When viewed from the incisal the existing individual veneers are not symmetrical, contributing to the bulbous contour (Fig. 3). The appearance is further compromised when examining

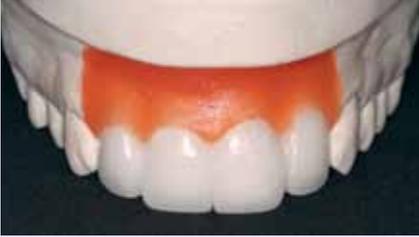
FIGURE 4

orthodontics to level the gingival contours among the four incisors framed by the canines. As the patient was looking for a more immediate result, time and additional finances were a strong consideration in the final treatment decision. To help visualize the outcome a diagnostic wax up was completed so that the patient could better understand the anticipated result (Fig. 4).

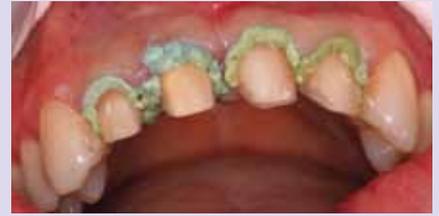
FIGURE 6

Prior to taking the final impression, the sulcus was not packed so as to avoid mechanical manipulation. Expasyl (Kerr-Sybron, Orange, CA) was placed on the sulcus to achieve haemostasis and retraction. The material was left on for two minutes then washed off with copious amounts of water and the teeth were then dried

(Fig. 6). The final impression of the maxillary arch was taken with a standard polyvinyl siloxane material. The impression, opposing arch, occlusal registration (Kois Dental Facial Analyzer) and laboratory script were packaged and sent to the ceramist.

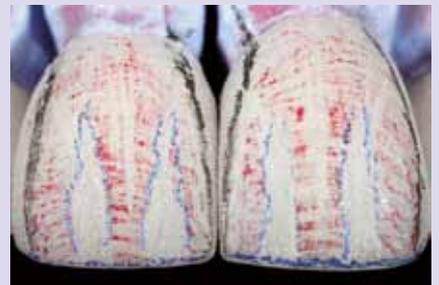
FIGURE 12

for any marginal imperfections and the correct interproximal contact areas were established. Facial markings illustrating reflective and deflective facial surfaces of the restorations were incorporated (Fig. 12).

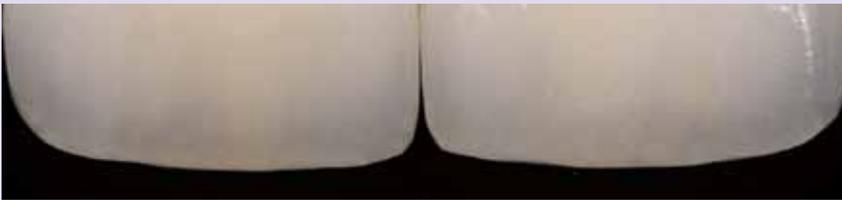
FIGURE 16

lished and confirmed visually, the incisal cutback was completed. The incisal cutback allowed for higher translucency ceramics to be applied to the more opaque substructure. It is important to ensure that the internal anatomy of the restorations are anatomically correct compared to the facial anatomy of the restorations. Internally, the higher translucency and opalescent ceramics were layered on to the cutback as to establish the internal window. The lower translucency opalescent ceramics were layered over this window as to mask the internal dentine forms, giving a more natural and anatomically correct incisal appearance with the presence of an incisal halo. This can be seen after final glazing and rotary polishing of the restorations (Figs. 15,16).

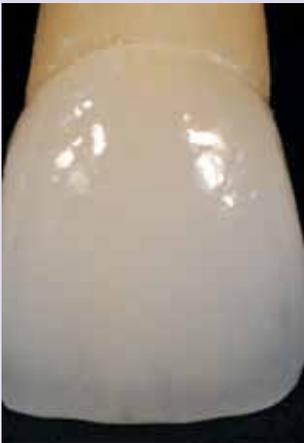
FIGURE 17

The restorations were checked for the appropriate chroma and value on custom composite aesthetic custom dyes as to closely resemble the intraoral and clinical situation as best as possible (Fig. 17).

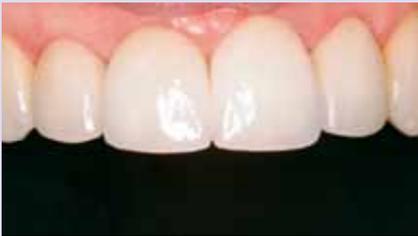
FIGURE 21

nate impression was taken for the fabrication of an Essex retainer to be worn at night. The purpose is to offer protection of the porcelain and act as a retainer preventing any movement. The patient was instructed to do warm salt-water rinses two times per day for the next week so that the gingival tissues would heal around the new restoration. The patient was then scheduled to return seven days later for dispensing of the Essex retainer, check of the new restorations — including removal of any left over resin tags and final photographs (Figs. 21-23).
